Flight Summary: WB-57F MidCiX - 30 April 2004

<u>Purpose of Mission:</u> Sample cirrus under EOS Terra satellite.

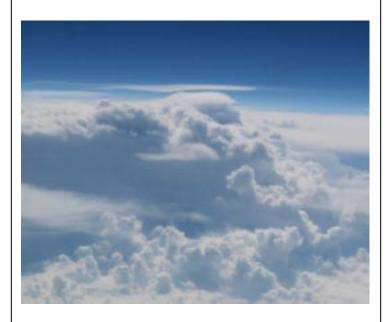
Top: Cirrus layers observed above a cumulonimbus cell early in the flight. Bottom: Halo visible in the cirrus with cumulus below.

- At 15:10, we descend down to FL 410. At 15:15, a big storm cell was at about our 2 o'clock that had a tremendous amount of blowoff to the northwest. The main cell topped out about FL 430. The top of the cell cloud had a laminar "cobweb" of cloud covering it, and a thin wisp of cirrus directly over it, following the contour of the storm cell.
